Comparison of Doppler radar to thermal infrared rockfall detection

Abstract

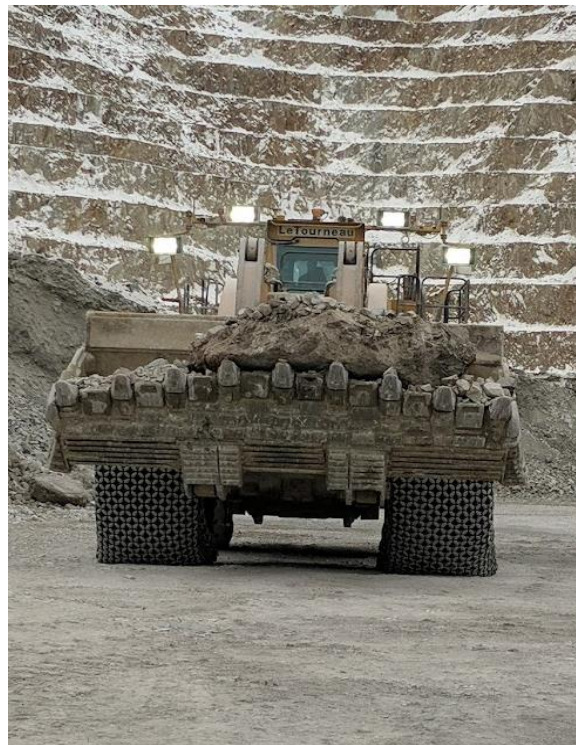
Figure 2. Mine loader carrying a boulder to be dropped for synthetic rockfall test.

A controlled synthetic rockfall test was conducted at the mine on January 11, 2022, where four separate controlled drops were conducted with various known-sized boulders. This test was completed by mechanically dropping rocks off the edge of a snow-covered overspill slope with a loader. Boulders ranged from as large as three meters (ten feet) to as small as one meter (three feet). Table 3 details the four controlled drops completed, and Figure 2 shows a mining loader carrying one of the boulders that was dropped as part of the test.

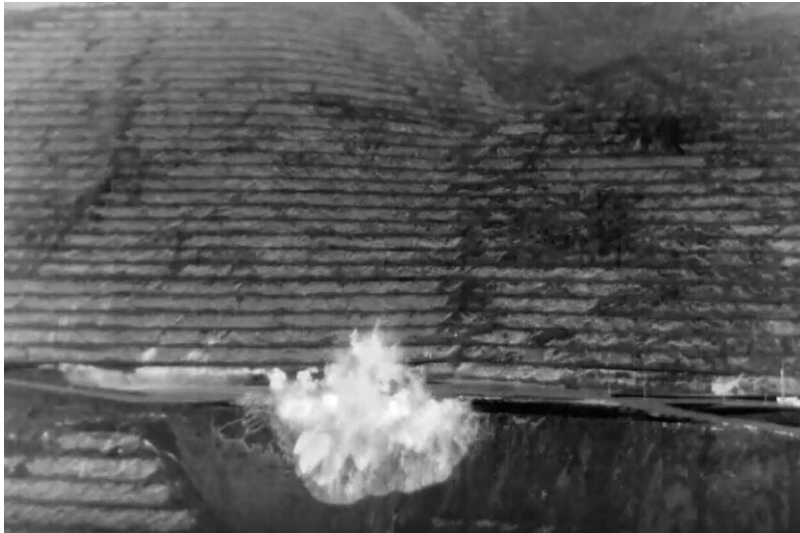
Figure 5. CAM2 thermal imagery capture of a blast event.

A blast event initiated on December 7, 2021 was captured by both systems. This blast was located on the pit edge side of the active mining level and resulted in material travelling down the side of the overspill slope. The blast was in the field of view of two of the cameras, and CAM2 captured the entire event in full horizontal view. The lower levels were not captured (Figure 5) due to the camera's position. The thermal cameras that captured the event recorded the heat generated by the blast with respect to the surrounding colder rock surfaces, which is shown in Figure 5 as a white-hot plume. The RockSpot Doppler radar system also captured the blast and could track rockfall down the slope below, as shown in Figure 6. A rockfall intensity heat map generated by the GeoCloud software captures the event's entirety and is shown in Figure 7.

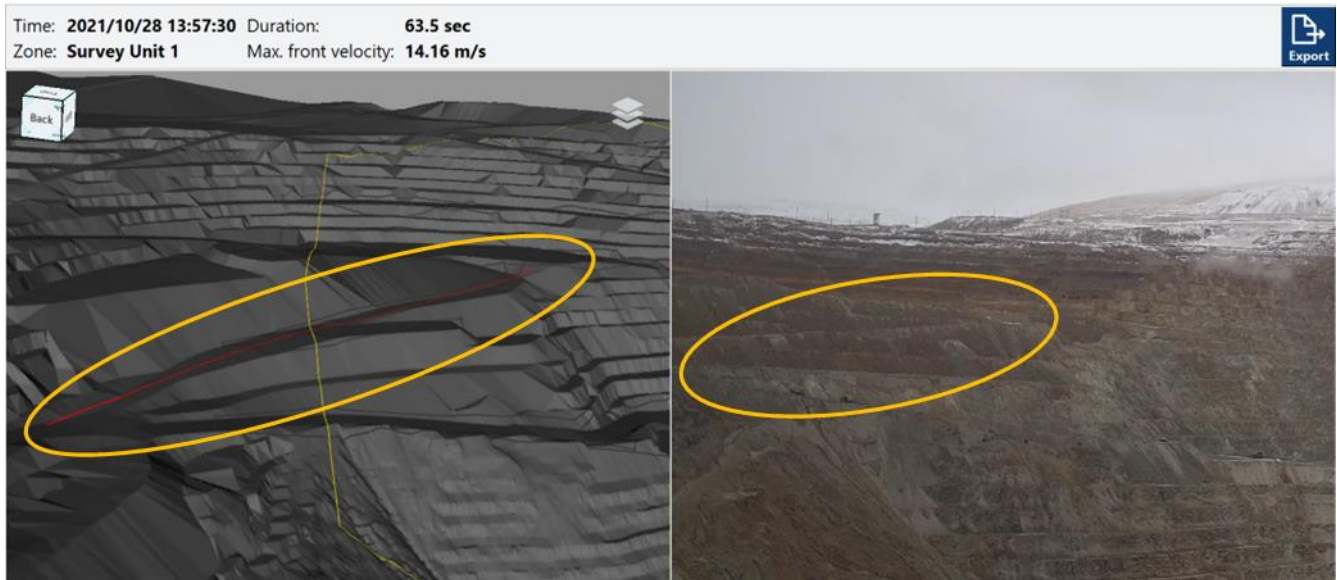
Figure 11. RockSpot Doppler radar "unwanted" detection of a haul truck driving on a haulage ramp.

Unwanted detections by the radar tracking algorithm results in the detection of events not related to falling rocks, such as detecting a haul truck driving on a ramp or a loader pushing material over the crest (Davidson, 2022). This type of equipment is constantly moving at a mine site and is highly reflective of the radar. Figure 11 shows unwanted detection of a haul truck driving on a ramp by the RockSpot system. Flowing water within the monitoring area can also cause unwanted detections.
