# Rockfall Barrier Testing in an Open Pit Mine: Comparing Empirical and Modeled Rockfall Dynamics

This paper presents preliminary results of a real-world rockfall test in an open pit mine using a synthetic (fiber-reinforced concrete) boulder that impacted a prototype rockfall barrier system. The kinetics of the test rockfall upon impact with the barrier are compared with a best-fit rockfall model, and the kinematics of the rockfall trajectory are evaluated with respect to the achieved highwall configuration.

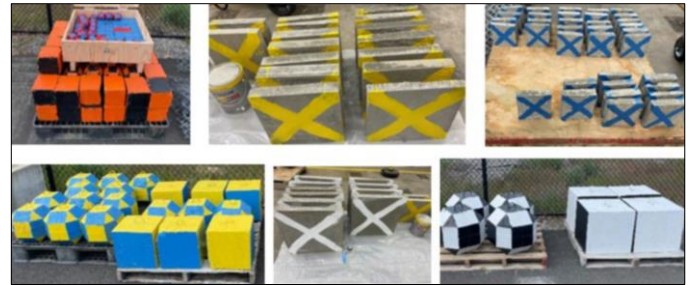
Figure 2. Variety of synthetic rocks created by NIOSH for rockfall testing (from Warren et al., 2022).

The tests utilized synthetic 'rocks' made of cast concrete and fiber reinforcement created by the NIOSH team, with various dimensions as shown in Figure 2. The variety in size and dimensions of the synthetic rocks is meant to mimic the natural variety of loose rock that may become rockfall hazards (Warren et al., 2022).

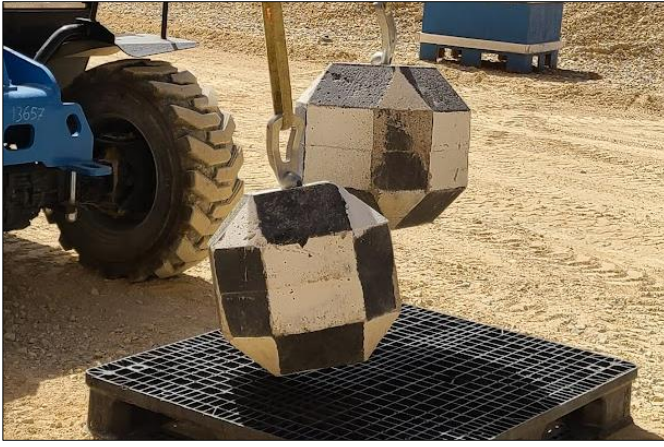
Figure 3. R1-type synthetic rhombicuboctahedron-shaped rocks.

Rockfall tests were initiated from the upper haul road (UHR) using a telehandler tractor by loading the rocks onto a wooden pallet, setting the pallet on a flat-top berm on the highwall crest along the UHR, and using another pallet attached to the telehandler forks to push the rocks over the edge. Most rocks were caught by intermediate benches, however several successfully made it to the lower haul road (LHR), impacting the rockfall barrier system described below. Over 300 rocks were sent down the slope during the daylong test, and the NIOSH team plans to analyze the full results of these tests with respect to bench performance. A solitary rhombicuboctahedron-shaped rock measuring 46 cm in diameter and weighing ~172 kg, known here as R1 (Figure 3), impacted the barrier with appreciable force and is the focus of this analysis.
